Model: Moto Guzzi 1200 8V engines

Subject: Operations on valve bucket tappets

Operational technical note

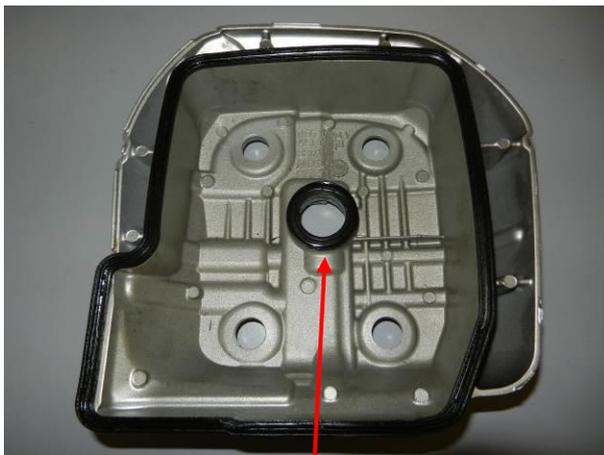
OK

To verify whether the vehicle can be modified with **kit A** remove the timing cover and check whether it is the floating type, which can be recognised by the presence of the circlip in the spark plug hole area:
